Inspection Report

-Fehr Brothers Swine Farm

Minonk Facility (formerly Neisler Facility)

CAFO Inspection

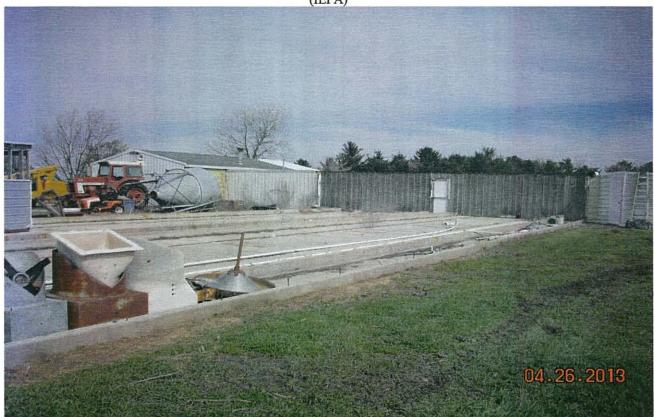
As seen in the photographs, swine confinement building #6 (far west building) has been partially demolished. Only the concrete floor and manure pit remain in place. Swine building # 5 is empty and will also reportedly be demolished. Mr. Fehr indicated that the farm intends to construct a new swine confinement building in the general footprint of existing buildings #5 and #6. This proposed new swine confinement building will be approximately 100 feet wide x 200 feet long. It will include a total manure storage pit approximately 10 feet deep beneath the building. The representatives indicated that they hoped to begin construction on the new building this spring.

Photograph #1. The condition of the western most swine building is shown. View is northwest.

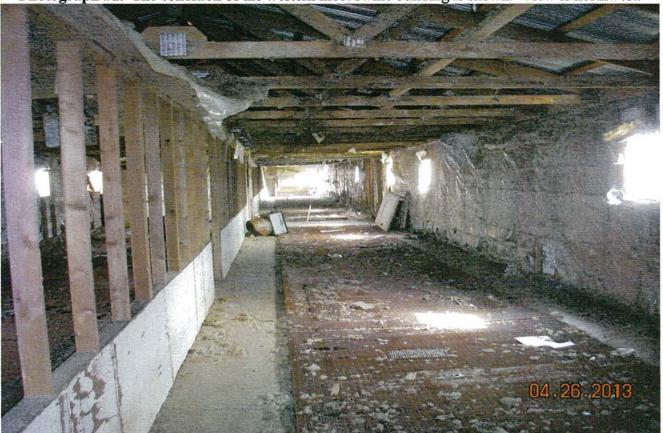
Photograph #2. The interior of a swine confinement building is shown. Page 1 of 8

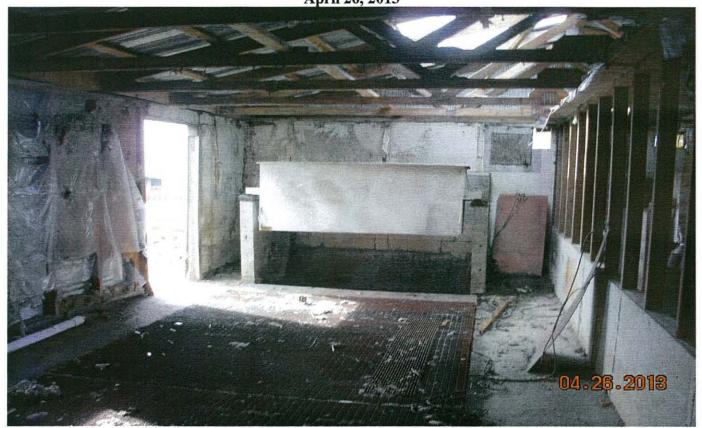
Photograph #3. Interior of a swine confinement building is shown. A tip tank for gutter flush in background.

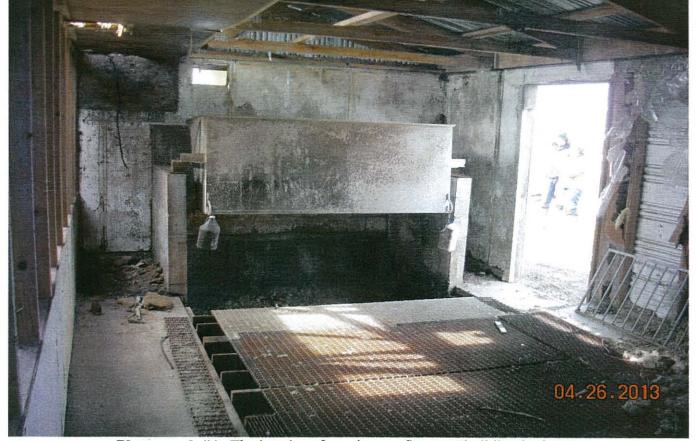
Photograph #4. The interior of a swine confinement building is shown.

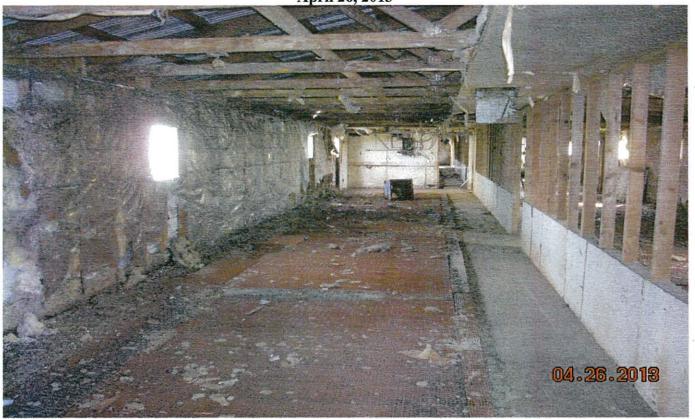
Photograph #5. The interior of a swine confinement building is shown.

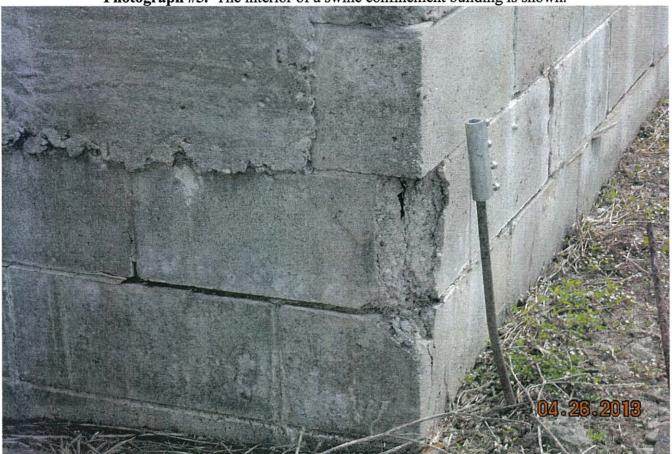
Photograph #6. The exterior block foundation wall of a swine confinement building is shown. View is north.

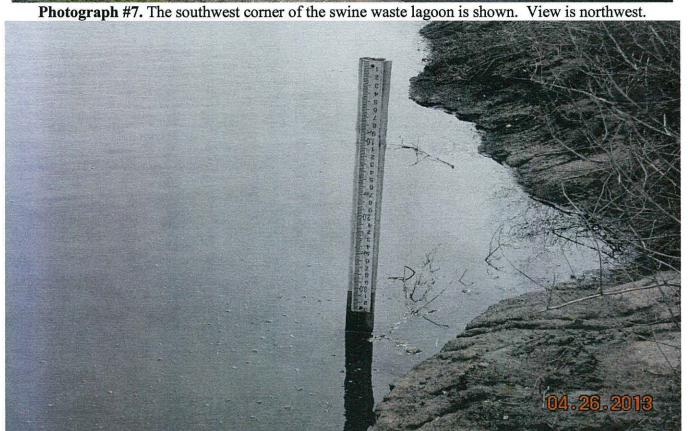
As seen in the photographs, the freeboard marker in this lagoon is delineated in tenths of feet and not inches. Also, the freeboard marker does not extend an adequate vertical distance within the lagoon to allow for appropriate freeboard monitoring and reporting. A discussion regarding an appropriate freeboard marker ensued.

Photograph #8. A freeboard marker is seen in the southwest corner of the swine waste lagoon. View is east.

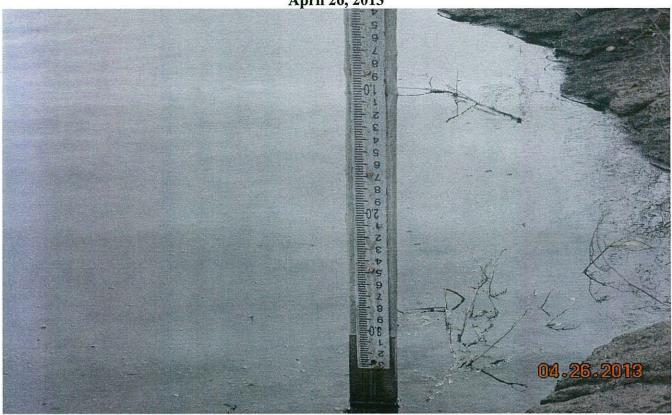
Photograph #9. A freeboard marker is seen in the swine waste lagoon.

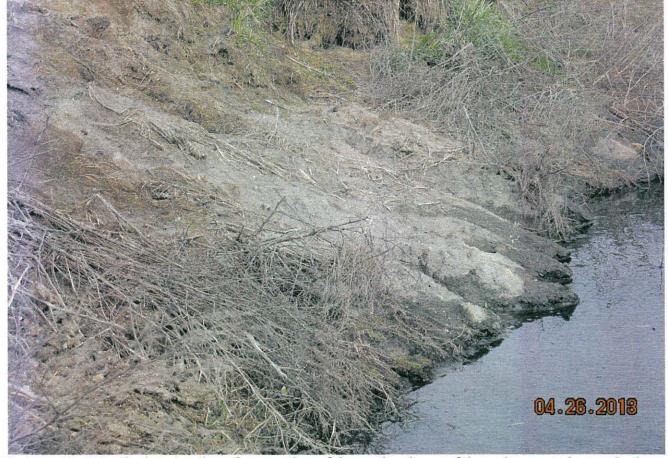
The swine waste lagoon was examined on the above date. This impoundment contained an estimated $3\frac{1}{2}$ feet of freeboard at the time of the inspection. I observed significant erosion on the inner slope of the earthen berms. The top of the berm is very narrow and does not allow for safe access and maintenance. Inner and outer berm slopes are too steep and have not been modified to meet appropriate slopes.

Photograph #10. The interior slope for a portion of the earthen berm of the swine waste lagoon is shown.

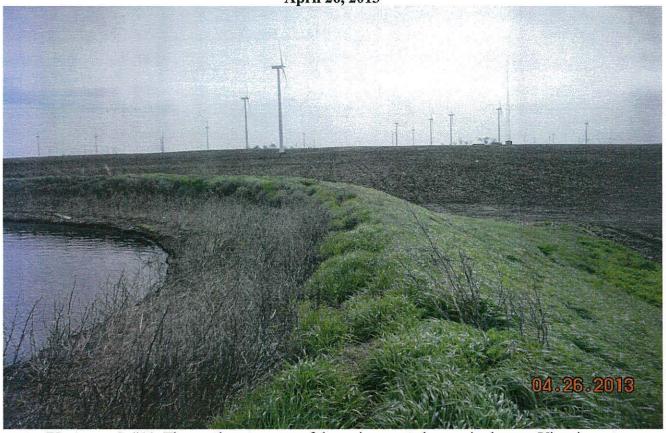
Photograph #11. The southeast corner of the swine waste lagoon is shown. View is east.

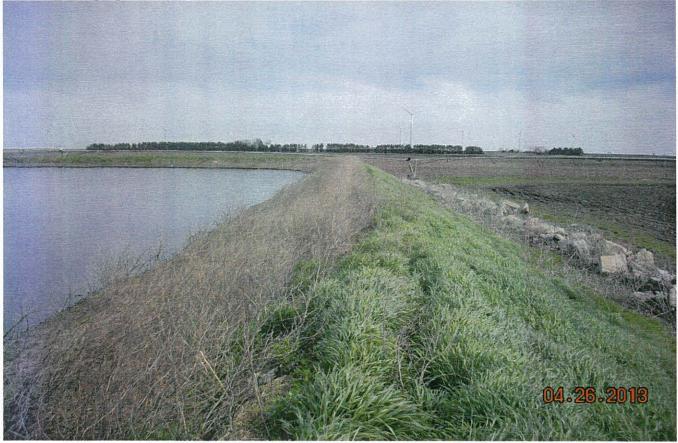
Photograph #12. The east berm of the swine waste lagoon is seen. View is north.

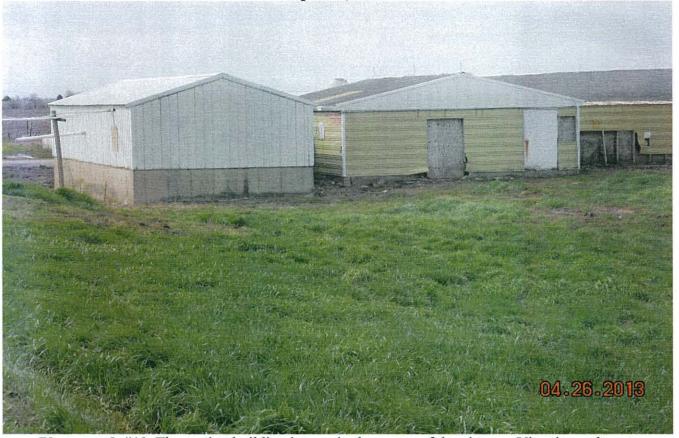
Photograph #13. The sorting building is seen in the center of the picture. View is southwest.

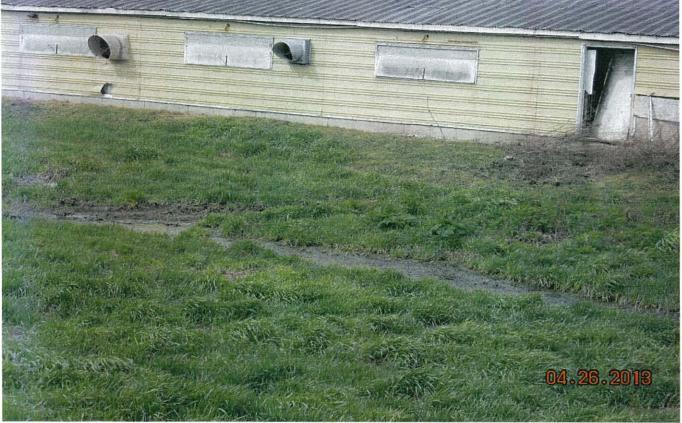
Photograph #14. A portion of a swine confinement building is shown. View is west.

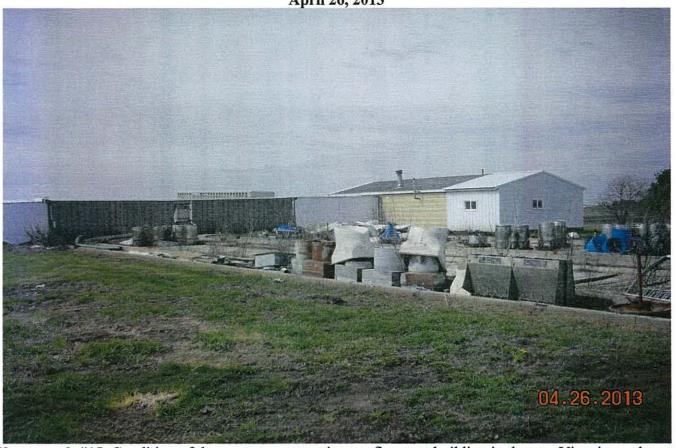
Photograph #15. Condition of the western most swine confinement building is shown. View is southwest.

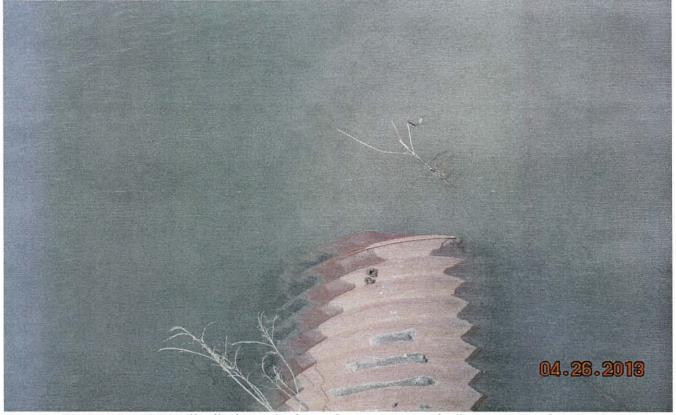
Photograph #16. Tile discharge is shown into an unnamed tributary to Panther Creek. c:\livestock\fehr_bros_swine_farm\minonk_2013\minonk_photos_digital_april_26_2013.doc
